Tree Condition Assessment of Black Pine *Pinus nigra*

32 St John's Road
Clifton
Bristol
BS8 2HG

Prepared by
Jim Walker TechArborA
All Tree Services Ltd

19th January 2017

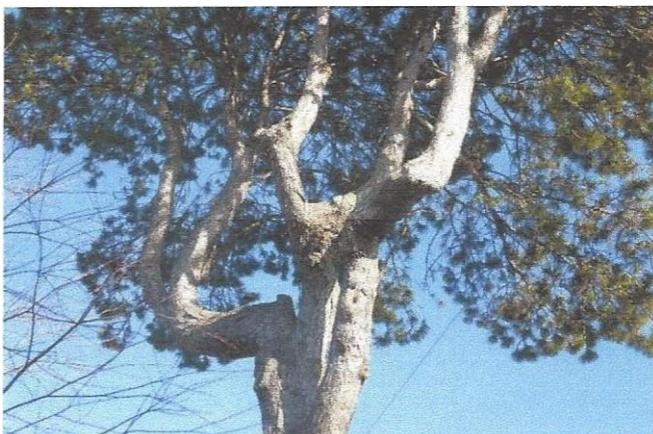
Plate 1

- 5.7 The main stem forks at 8.5m and 10m to three scaffold stems. It appears that historically the tree was topped at approximately 11m-12m. In response to this the surviving laterals have grown phototropically to form six vertical crown stems (Plate 1).

- 6.2 In general, the tree seems to be in fair structural condition with no obvious significant defects at the base or on the main stem. However, there are structural faults and signs of stress around the old topping point at approximately 10m-12m, where there are abruptly angled stem formations, tight fork unions, bark inclusions, fibre buckling and a small cavity.

- 6.9 In my opinion the tree may be retained in the short to medium term. However given its position close to residential properties I recommend that it is inspected annually and after periods of extreme weather. In addition, an aerial inspection should be undertaken within twelve months to investigate the identified defects around the old topping point at 10-12m, plus any defects not visible from the ground.

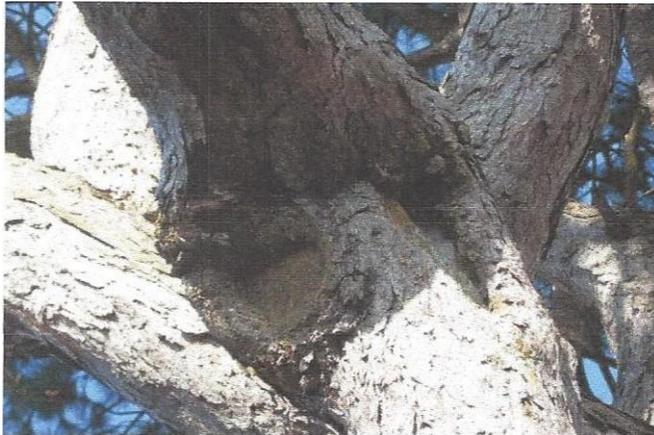
Plate 2

5.8 The southwest scaffold stem has an acute dog-legged formation at 11m, with an unoccluded pruning wound and open cavity below the elbow on the south/southeast aspect (Plate 2). The stem then grows vertically before dividing into two at 13m.

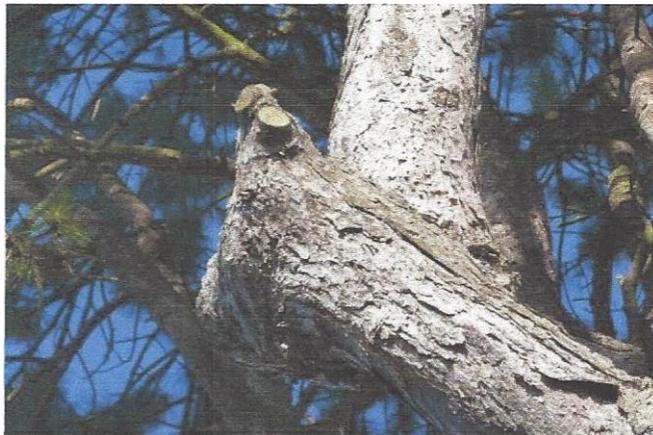
Plate 3

5.9 The central scaffold stem forks at 11m to two crown stems. The westernmost of these two stems divides again into two at 12m, one of which has recently been lost or removed. There is a large pruning wound, plus a possible compression fork union at the base of the remaining stem (Plate 3).

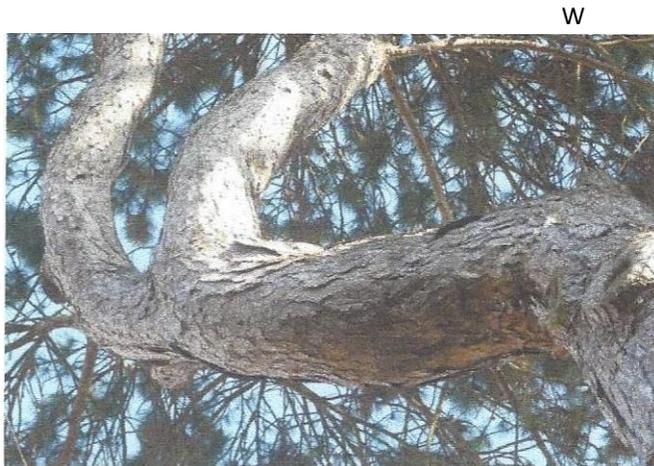
Plate 4

5.10 The northern scaffold stem at 10m grows horizontally for 1.5m before dividing into two vertical crown stems and one secondary stem. There appears to be some bark dysfunction and/or fibre buckling on the underside (Plate 4).
