Tree Condition Assessment of Black Pine *Pinus nigra*

32 St John's Road
Clifton
Bristol
BS8 2HG

Prepared by
Jim Walker TechArborA
All Tree Services Ltd

19th January 2017

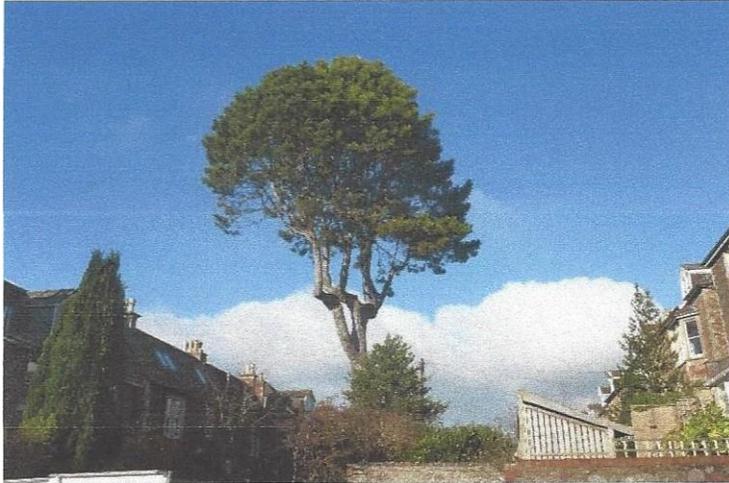
- 6.2 In general, the tree seems to be in fair structural condition with no obvious significant defects at the base or on the main stem. However, there are structural faults and signs of stress around the old topping point at approximately 10m-12m, where there are abruptly angled stem formations, tight fork unions, bark inclusions, fibre buckling and a small cavity.

- 6.4 Physiologically the tree is in fair condition, with no signs of imminent decline, although there is some light yellowing of foliage on the crown periphery.

- 6.6 In my opinion the most likely point of failure in strong winds will be from individual crown stems or branches. Due to past management and the current form of the tree, there is little scope for remedial work to reduce mechanical stress. Light crown thinning would help reduce the wind sail of the whole crown, but this may also increase exposure to unadapted growth and raise the likelihood of failure of individual crown parts.

- 6.9 In my opinion the tree may be retained in the short to medium term. However given its position close to residential properties I recommend that it is inspected annually and after periods of extreme weather. In addition, an aerial inspection should be undertaken within twelve months to investigate the identified defects around the old topping point at 10-12m, plus any defects not visible from the ground.
